Inspector's Daily Report

IDR Sheet	1	of	1	Sheets	Final Record Book	Page
Contract				Day		Date
	C-7852	2		We	ednesday	September 7, 2011

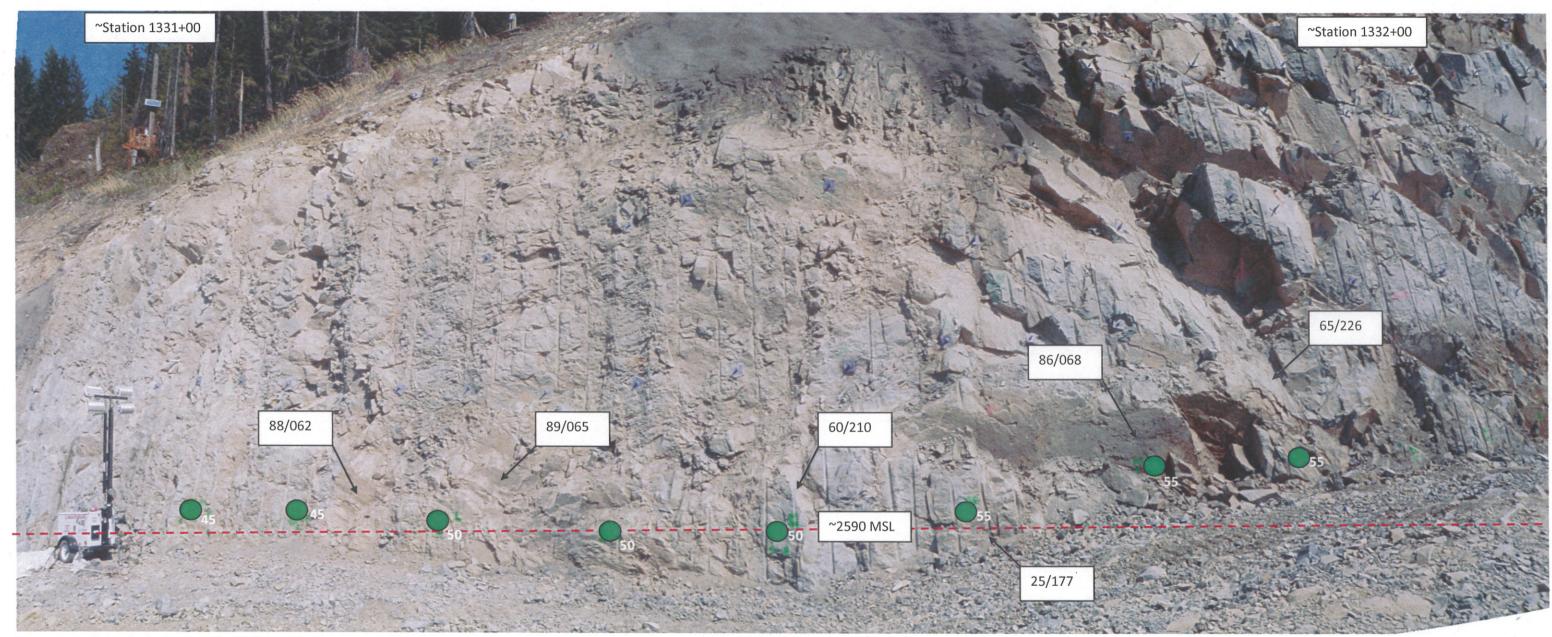
Figure 1. A photograph showing the lift inspection from approximate station 1331+00 to 1332+00 at approximate elevation 2590 MSL.

55 - Type L Pattern Dowels (Minimum Length in Feet)

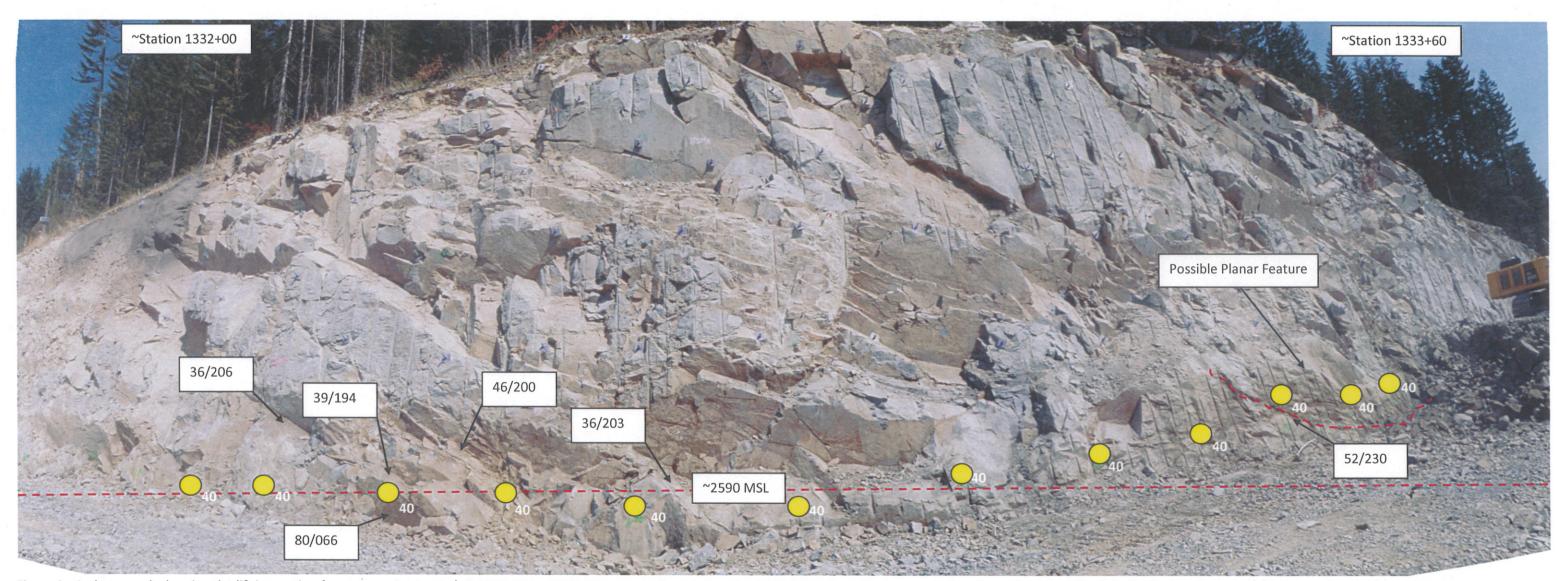
Figure 2. A photograph showing the lift inspection from approximate station 1332+00 to 1333+60 to approximate elevation 2590 MSL. Note the three rock dowels on the right side of the figure have been moved up into the possible planar feature.

40 - Type H Rock Dowels (Minimum Length in Feet)
